PRI Construction Materials Technologies LLC

Laboratory Test Report

Product Name(s): Ceilume Stratford / Ceilume Cambridge / Competitor

Test Methods: ASTM C 367

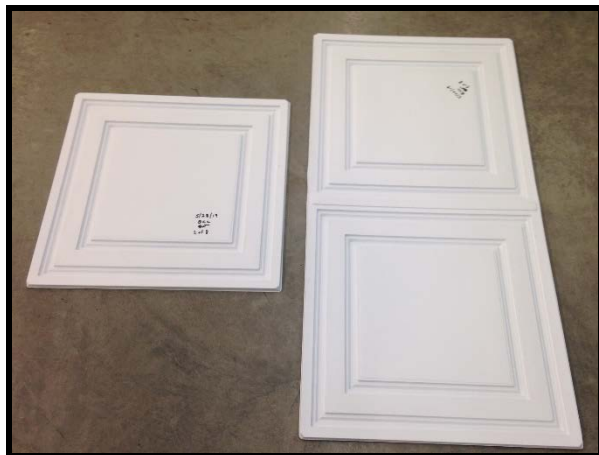
Statford

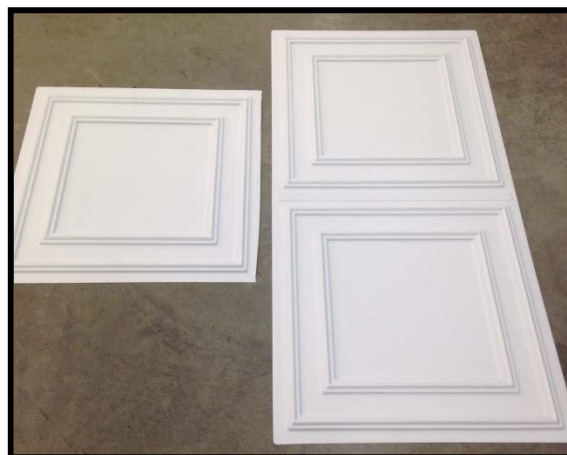
Cambridge

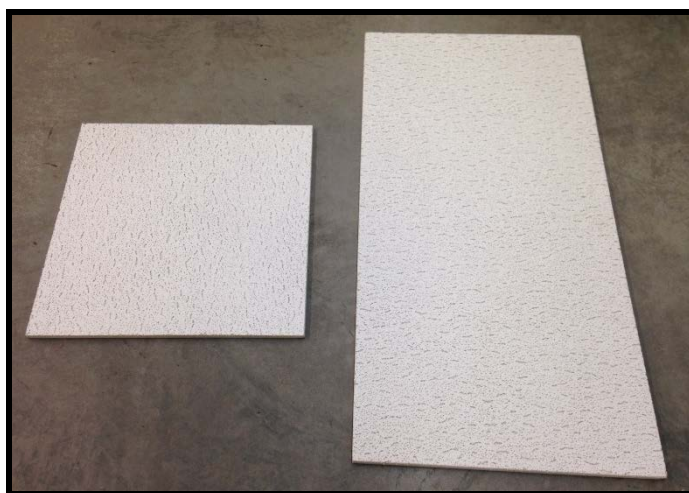
Competitor (Mineral Fiber)

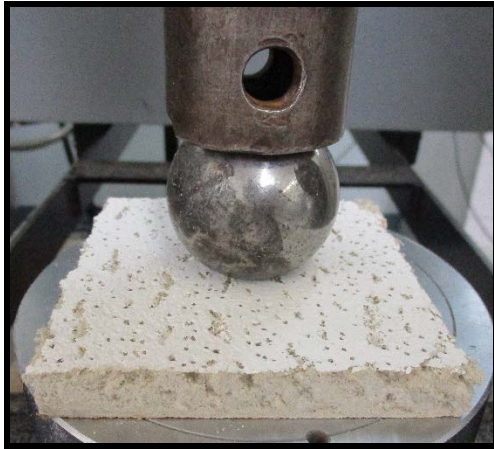
Hardness

Competitor (Mineral Fiber)

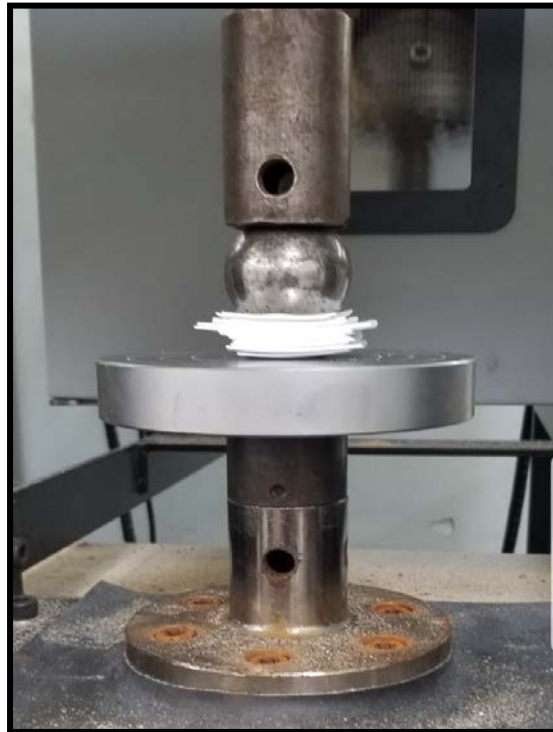
Stratford / Cambridge (Typical)

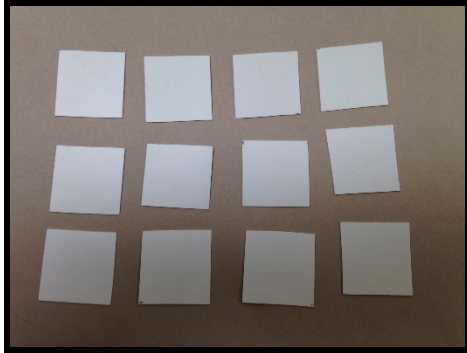
Friability

Stratford – Before

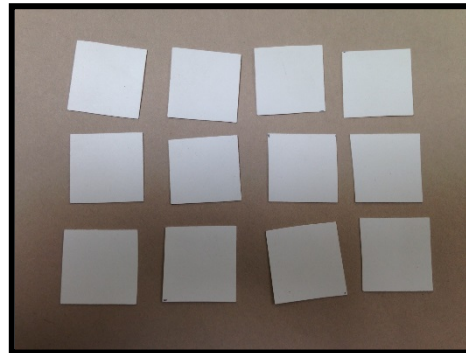
Stratford - After

Stratford (Vinyl)		0			0				Report
Cambridge (Vinyl)		0			0				Report
Competitor (Mineral Fiber)		8.7			13.5				Report
Sag (in) 2 specimens; 2' x 4' x Thickness; Cond. 24hr @ 73±2°F & 50±2% RH Expose 17hr @ 90±3°F & 90±2% RH Recover 6hr @ 73±2°F & 50±2% RH	ASTM C367 Sec. 21	Humidity induced Sag			Recovery (Permanent Sag)				
Stratford (Vinyl)	Sample 1	0.091			0.100				Report
	Sample 2	0.086			0.092				Report
Cambridge (Vinyl)	Sample 1	0.035			0.039				Report
	Sample 2	0.041			0.044				Report
Competitor (Mineral Fiber)	Sample 1	0.713			0.766				Report
	Sample 2	0.666			0.761				Report
Sag (in) 2 specimens; 2' x 2' x Thickness; Cond. 24hr @ 73±2°F & 50±2% RH Expose 17hr @ 90±3°F & 90±2% RH Recover 6hr @ 73±2°F & 50±2% RH	ASTM C367 Sec. 21	Humidity induced Sag			Recovery (Permanent Sag)				
Stratford (Vinyl)	Sample 1	0.072			0.072				Report
	Sample 2	0.069			0.071				Report
Cambridge (Vinyl)	Sample 1	0.033			0.033				Report

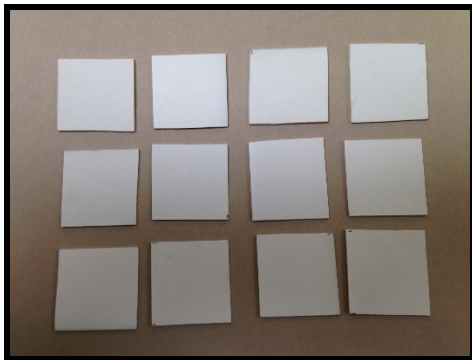
Cambridge – Before

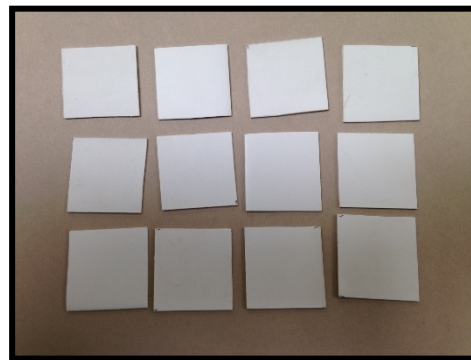
Cambridge - After

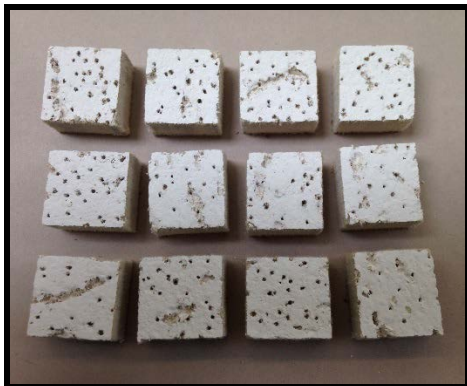
Competitor (Mineral Fiber) – Before

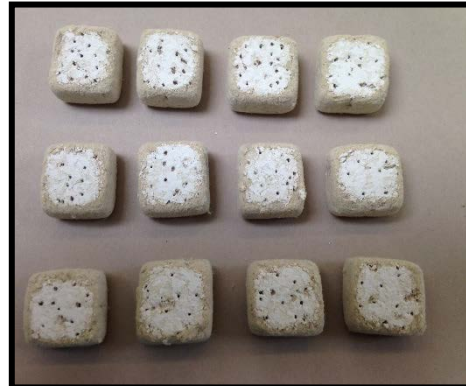
Competitor (Mineral Fiber) - After

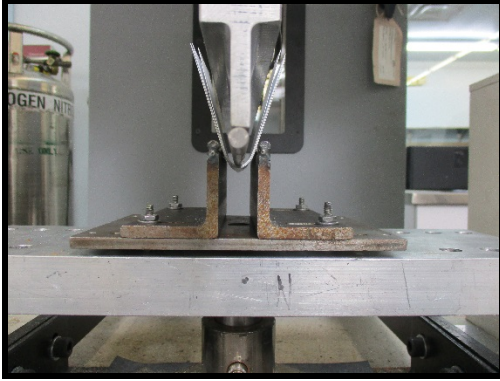
Transverse Strength – Span Distance Calculated by a 16:1 Ratio of Sample Thickness

Stratford

Physical Properties	Test Method	Results							Requirement ¹
Transverse Strength 5 specimens; 16:1 span ratio Cond. 24hr @ 73±2°F & 50±2% RH Rate: 1in/min	ASTM C367 Sec. 28	1	2	3	4	5	Avg.	St. Dev.	
Stratford (Vinyl)									
Modulus of Rupture; (psi)		1150.6	1101.4	1124.3	1558.2	1554.9	1297.9	236.7	Report ^{1,2}
Break Load; (lbf)		NA	NA	NA	NA	NA	NA	NA	Report ³
Cambridge (Vinyl)									
Modulus of Rupture; (psi)		1514.0	1742.4	1737.7	1694.5	1710.7	1679.8	94.8	Report ^{1,2}
Break Load; (lbf)		NA	NA	NA	NA	NA	NA	NA	Report ³
Competitor (Mineral Fiber)									
Modulus of Rupture; (psi)	MD	78.7	81.1	78.6	74.0	76.2	77.7	2.7	Report
	XMD	105.1	115.4	119.8	112.4	116.2	113.7	5.5	
Break Load; (lbf)	MD	5.7	5.9	5.7	5.3	5.5	5.6	0.2	Report
	XMD	7.6	8.3	8.7	8.1	8.4	8.2	0.4

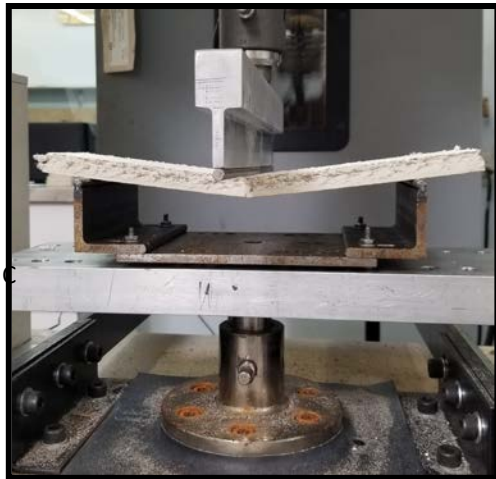
Competitor (Mineral Fiber)

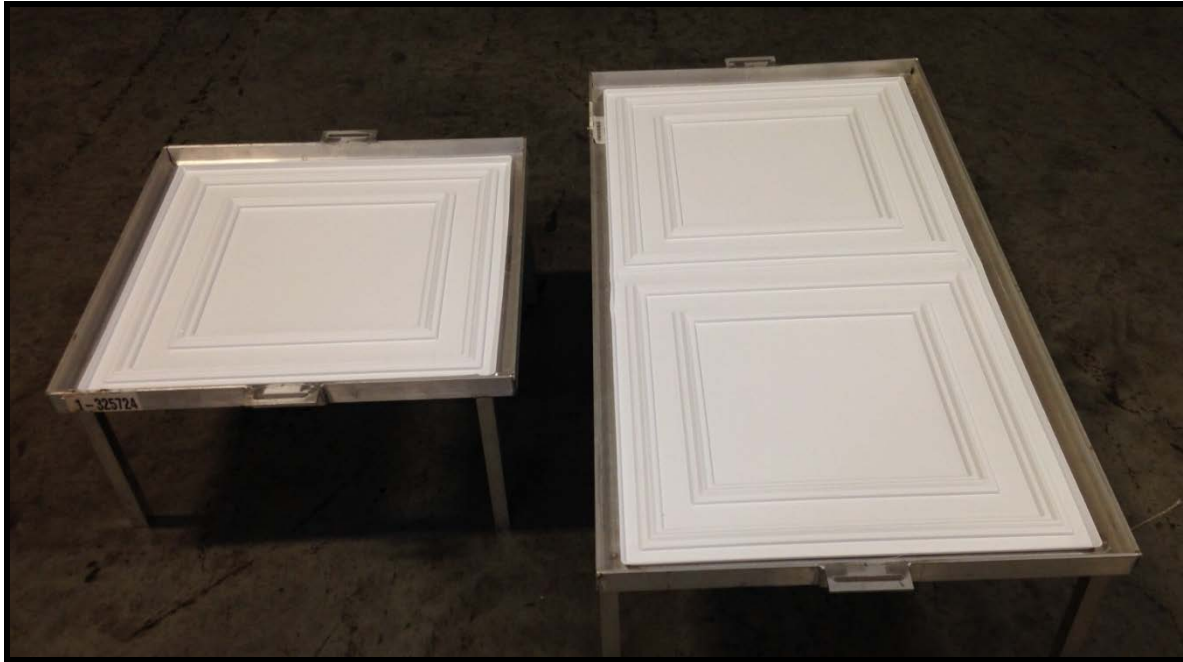
SAG

Stratford - Before

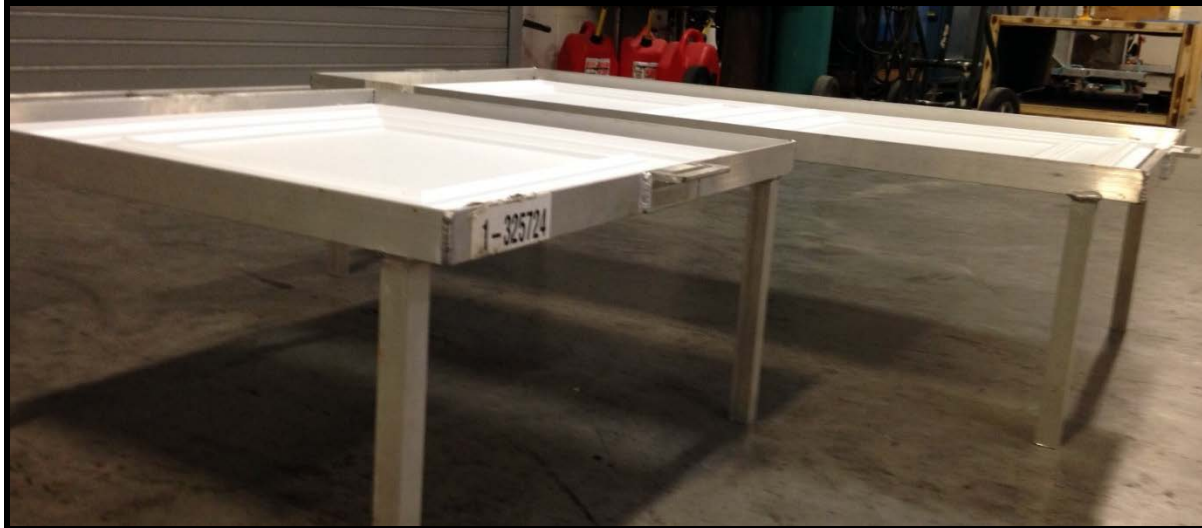
Stratford - After

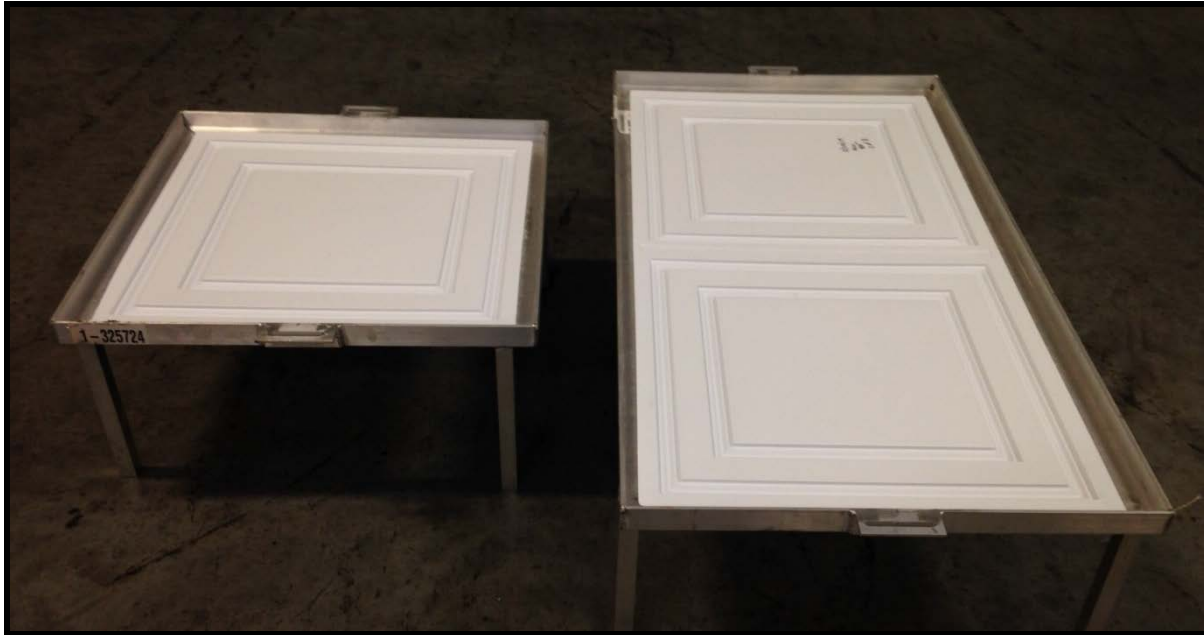
SAG – Continued...

Cambridge - Before

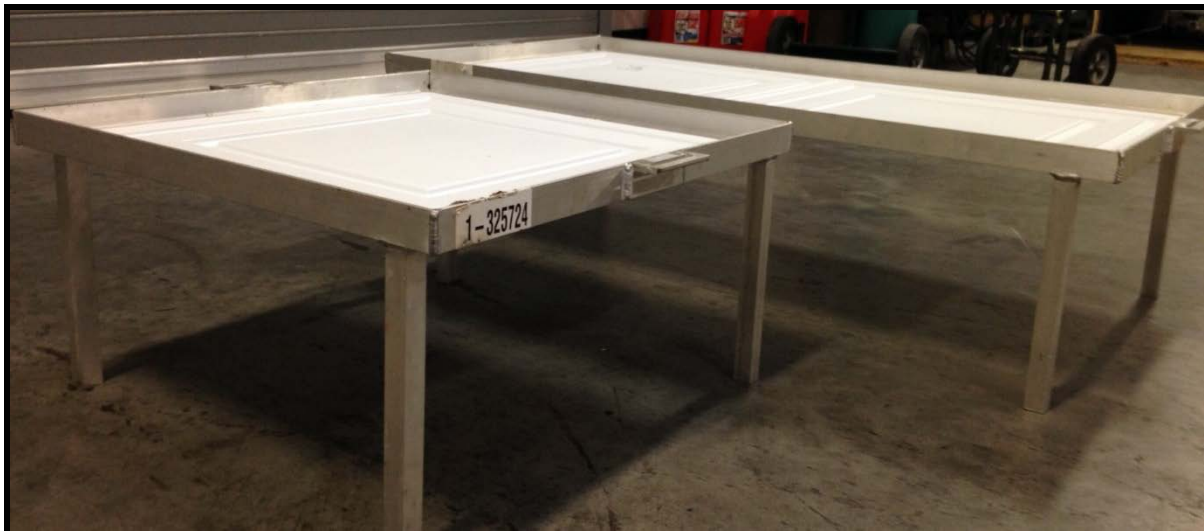
Cambridge - After

Sample 2	0.030			0.031				Report
Competitor (Mineral Fiber)	Sample 1	0.267			0.259				Report
	Sample 2	0.305			0.365				Report

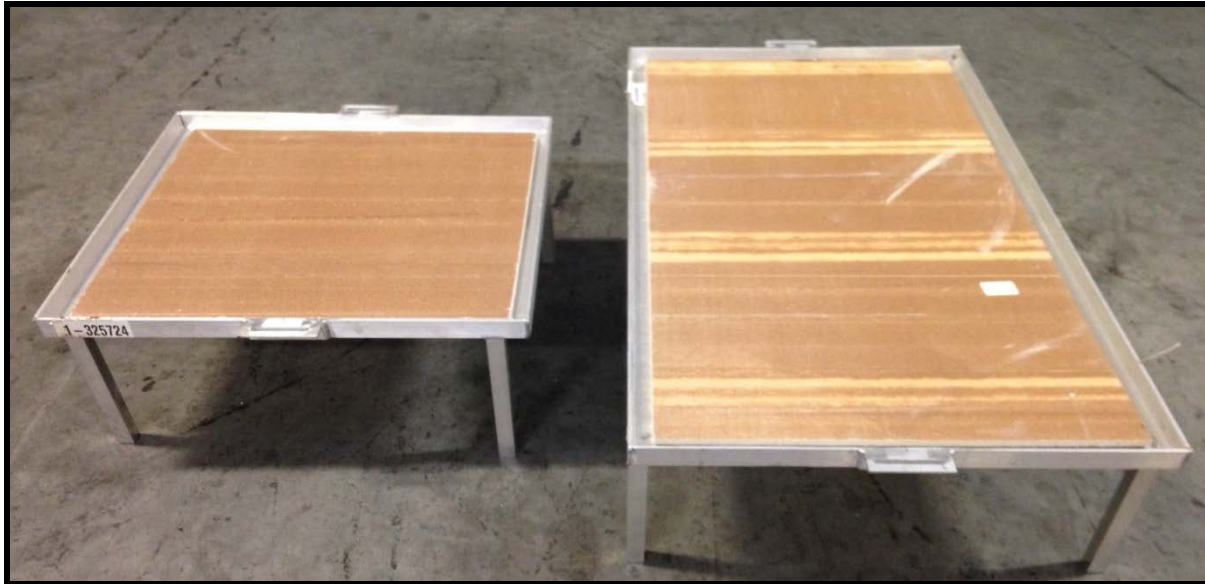
SAG – Continued...

Competitor (Mineral Fiber) - Before

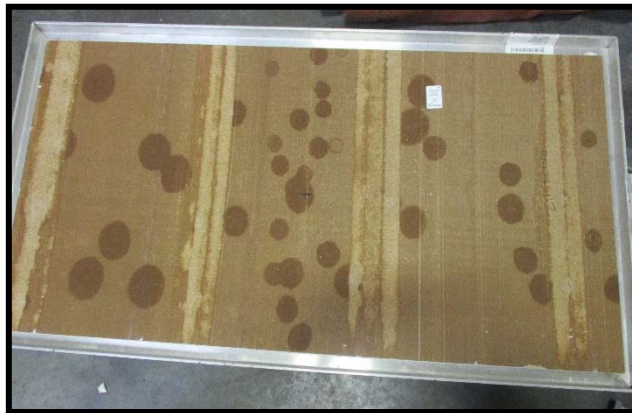
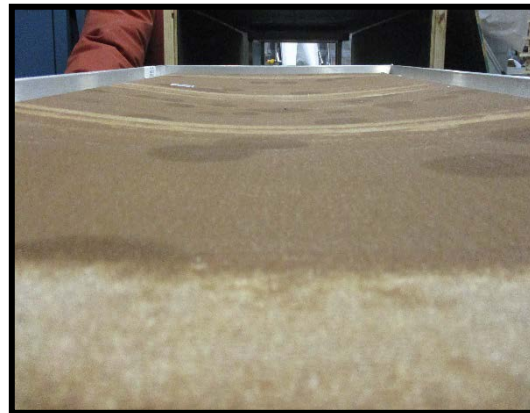
Competitor (Mineral Fiber) - After
