PRODUCT NEWS - FOR IMMEDIATE RELEASE

## Testing the Strength of a Good-Looking Ceiling

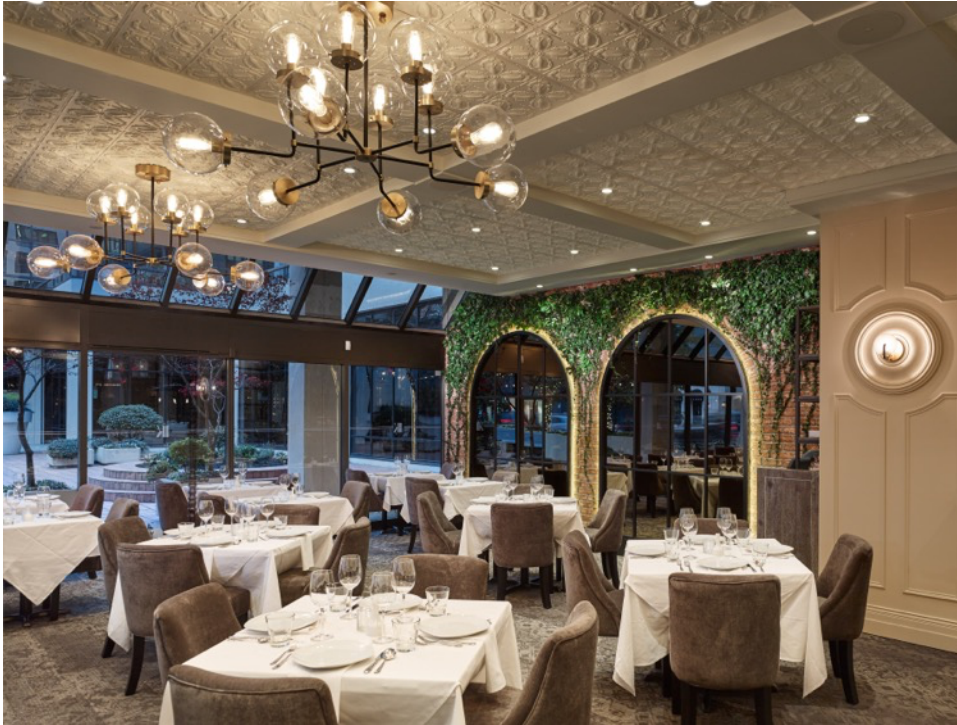
**Test data can help determine whether thermoformed acoustic ceiling panels such as these are a more durable alternative to common mineral fiber acoustic panels.** Photo by Martin Knowles

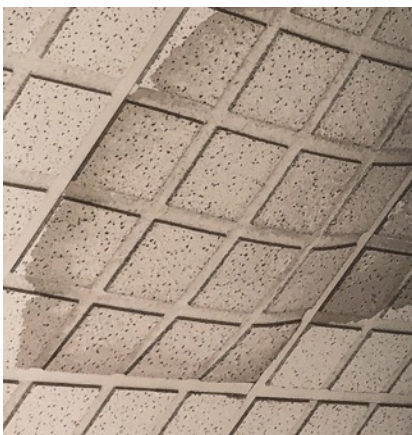
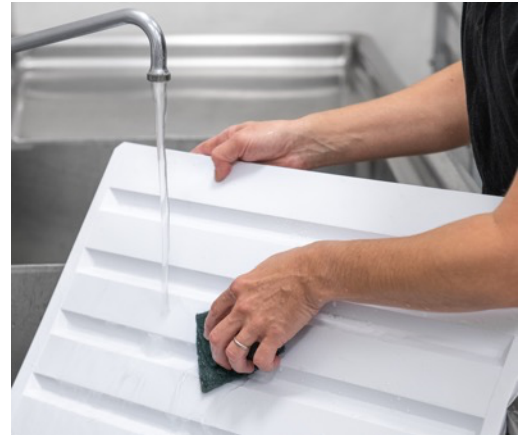
**Left and Center:** Mineral fiber ceiling panels absorb moisture and lose strength, resulting in sagging. Moisture also promotes staining, odor, and fungal growth. **Right:** Thermoformed panels are impervious to water and not prone to sagging. They also resist water-borne stains and are washable. (Photo by Ryan Bent)

- *Sag:* Panels are exposed to elevated temperature and humidity, then returned to ambient room conditions and measured for sag. Thermoformed panels exhibited less than 1/10-inch of sag. Mineral fiber had more than 3/4-inch of sag because they have a propensity to weaken as they absorb moisture. A 3/4-inch sag would be clearly visible at normal suspended ceiling heights.

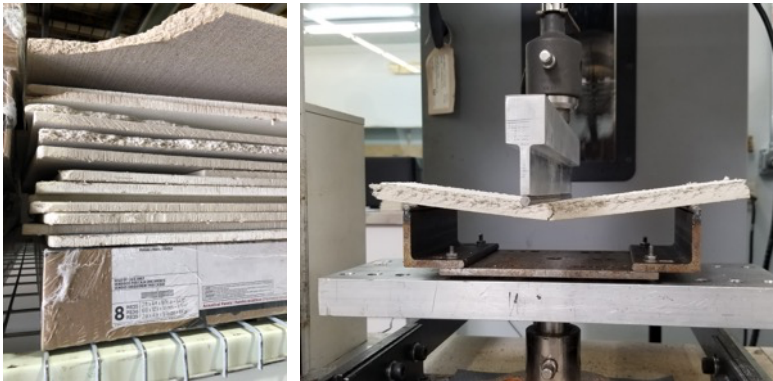
**Left:** Field experience indicates that mineral fiber ceiling panels are fragile and can be damaged by ordinary shipping and handling.

**Right:** ASTM C367 tests confirmed that mineral fiber ceiling panels break at relatively low loads.

- *Transverse Strength:* Panels are tested in a hydraulic testing machine and the load is recorded at which panels break or are unable to resist more load. The greater the modulus of rupture (flexural strength), the less likely a panel is to be damaged in the field. Mineral fiber broke at a load of 5.6 lbf. Thermoformed vinyl did not break, and had a modulus of rupture 16 times greater than mineral fiber.

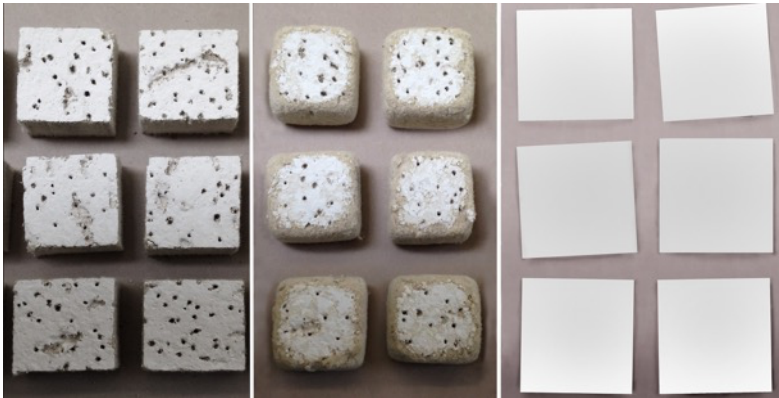
The ASTM C367 tumbling tests demonstrates how mineral fiber ceilings (left) erode and shed fibers (center) when handled. Thermoformed ceiling panel (right) do not contain fibers and are not damaged during testing.

- *Friability:* Specimens are placed in a rotating tumbler, then taken out and weighed at prescribed intervals. Specimens that lose the most mass are more friable and prone to damage, especially at corners and edges. The mineral fiber samples lost over 13% of their total mass in twenty minutes. Thermoformed panels lost nothing. Friability is especially a concern with mineral fiber materials because airborne fibers, including silica fibers, can cause respiratory and other health problems.

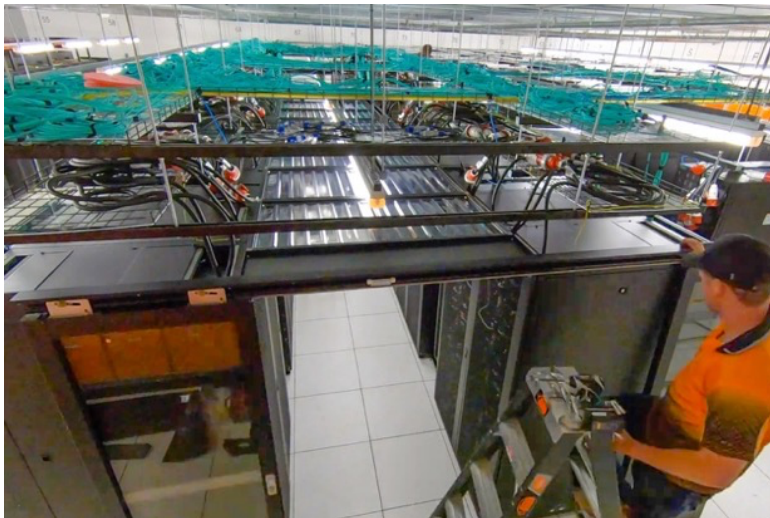
Thermoformed ceiling panels can be used in areas where airborne fibers are not acceptable, such as this computer server room, and in healthcare facilities and food preparation areas.
